<u>FSTE</u> well-designed Material Suction Cup vs. Ordinary Material Suction Cup Aging Test Description

This aging comparison test involves two suction cup products (Group A and Group B) and was conducted from March 1, 2020, lasting 180 days, until August 28, 2020.

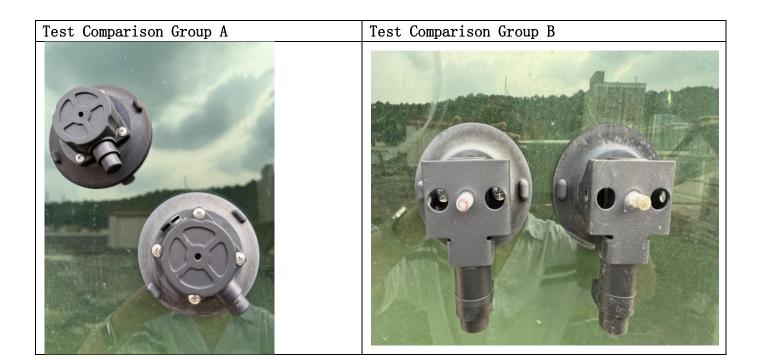
The test was conducted in Shenzhen, China, with both suction cups placed outdoors under natural environmental conditions, exposed to ultraviolet light, rain, dust, high temperatures, and other aging factors to simulate the real-world long-term outdoor usage of the suction cups. (As shown in the image below)

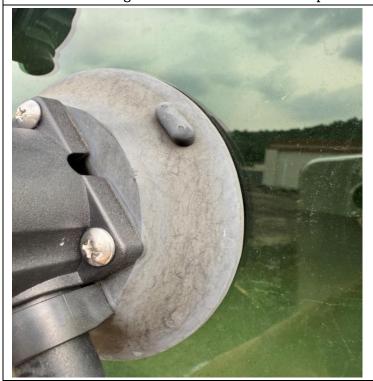
FSTE well-designed Material Suction Cup

The surface of the suction cup remains in good condition, with no visible cracks or peeling. The functionality is intact, and the appearance is still relatively new, demonstrating excellent weather resistance and stability.

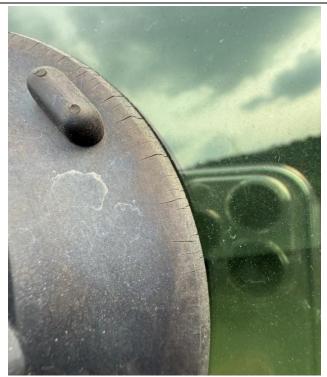
Ordinary Material Suction Cup

The surface of the ordinary material suction cup shows extensive cracking and aging, with noticeable hardening at the edges. This affects the adhesion function, and its aging resistance is poor, making it no longer suitable for continued use.

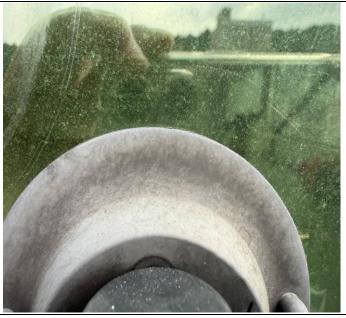
FSTE well-designed Material Suction Cup

The FSTE well-designed material suction cup demonstrated excellent weather resistance and stability during the 180-day aging test.

- The surface of the suction cup showed no noticeable cracks or signs of aging.
- The adhesion function remained normal, with a good appearance and strong adhesion power.
- Even under extreme weather conditions, the quality of the well-designed material suction cup was not significantly affected, proving its reliability for long-term use.

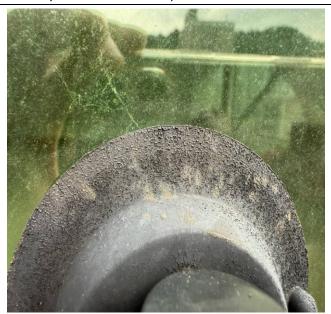
Ordinary Material Suction Cup

The aging performance of the ordinary material suction cup was poor, with noticeable cracks and severe aging signs:

- The surface of the suction cup exhibited large cracks, affecting its adhesion performance.
- The edges of the suction cup hardened and became brittle, significantly impacting its reliability for long-term use.
- In the later stages of the test, the adhesion strength of the ordinary suction cup decreased significantly, making it unsuitable for continued use.

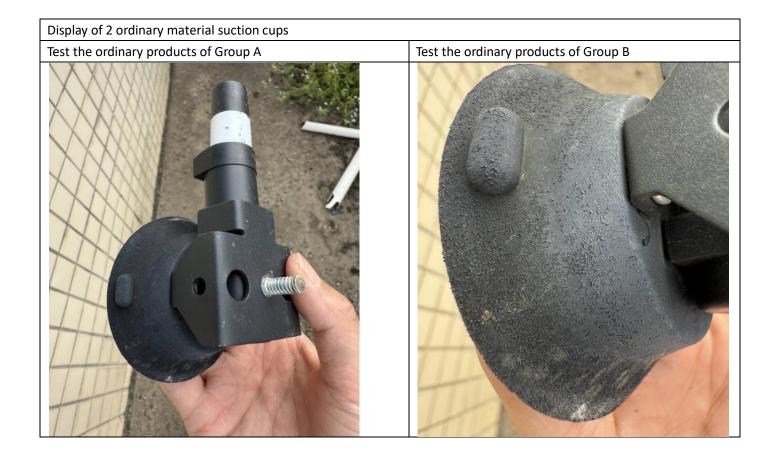
Conclusion:

Through comparative testing, FSTE well-designed compound suction cups demonstrated extremely superior aging resistance. We recommend them for applications requiring long-term outdoor exposure, such as automotive suction cups and outdoor advertising suction cups. In contrast, ordinary material suction cups are suitable for applications with shorter use cycles.
